# ENVIRONMENTAL QUALIFICATION TESTING OF TFE VALVE COMPONENTS

## ABSTRACT

A test program was undertaken at Chalk River Laboratories (CRL) to investigate the performance of three valves after irradiation to 10 Mrad. Such valves are currently used at the Bruce B Nuclear Generating Station. Each contains TFE packing rings; one also has TFE

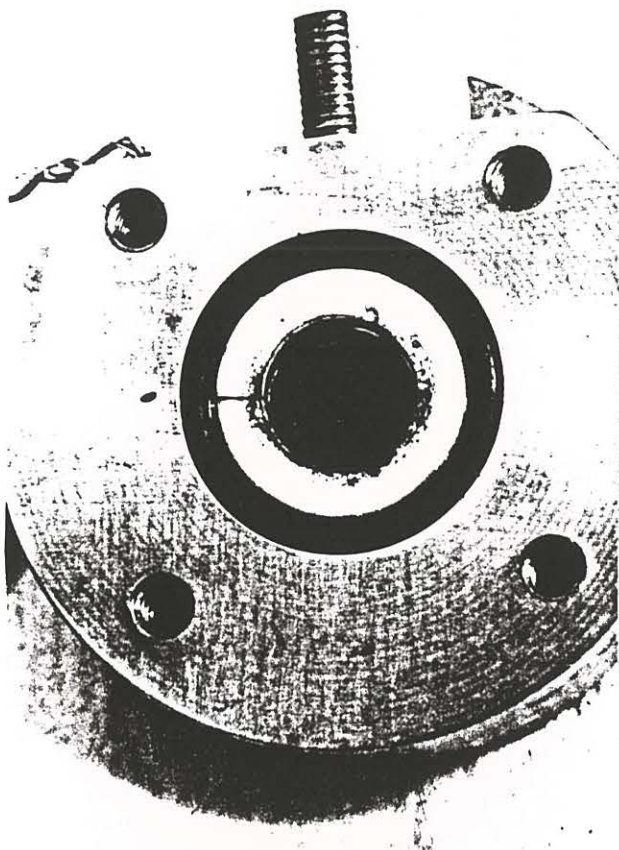
The front and back TFE seats of the Worcester valve were examined. Although there was no difference in colouration, the front seat had a single crack that went right through. This crack was located at one of six small notches in the outer edge of the seat. At least one leak test must have been performed after the break, because the crack faces were dirty from exposure to water containing rust particles. No other cracks were visible on either seat. Figure 5 shows the front seat with the crack.

It is possible the crack developed between the nominal 2 Mrad and 4 Mrad tests when the leakage for this valve increased substantially. However, the leakage dropped again for the last three leak tests, although not back to the levels at 0 and 2 Mrad. Regardless of when the crack developed, it did not result in drastic failure of the valve.

**FIGURE 5: Cracked Worcester Seat  
(dark line @ 9:00 o'clock)**

components. It is unclear when and why the crack developed in the Worcester seat but the most likely time is between the 2 Mrad and 4 Mrad leak tests. Despite the crack, the valve did not leak catastrophically.
