# EDDY CURRENT AND ULTRASONIC FUEL CHANNEL INSPECTION AT KARACHI NUCLEAR POWER PLANT

W. R. Mayo  
Atomic Energy of Canada Limited  
Chalk River Laboratories  
Chalk River, ON K0J 1J0

Muhammad Mansur Alam (PAEC)

## ABSTRACT

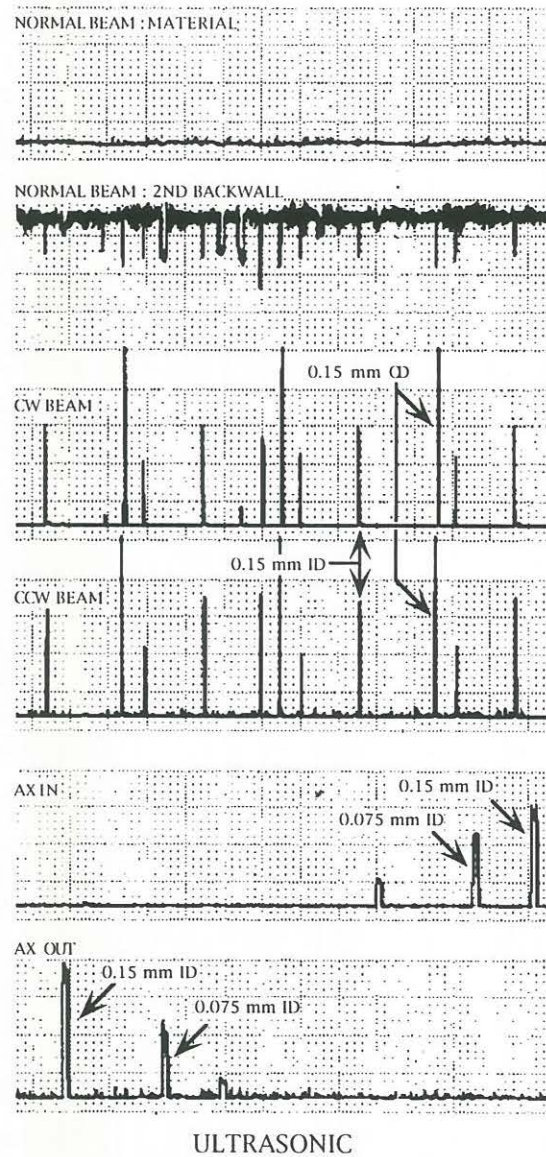
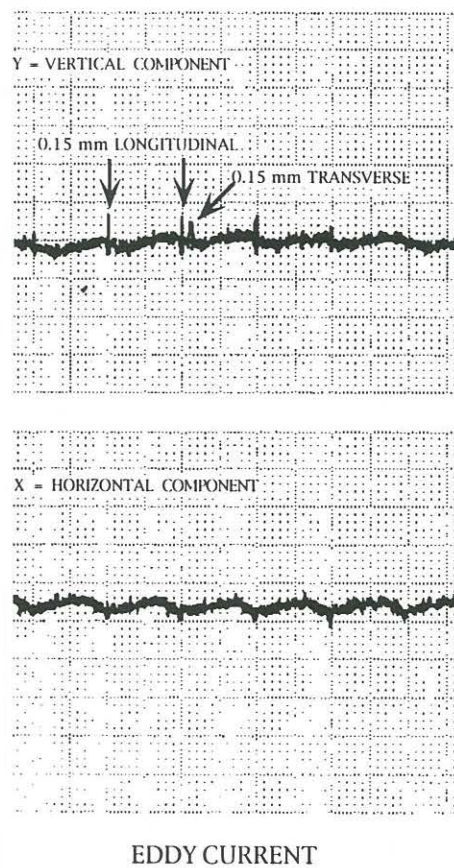
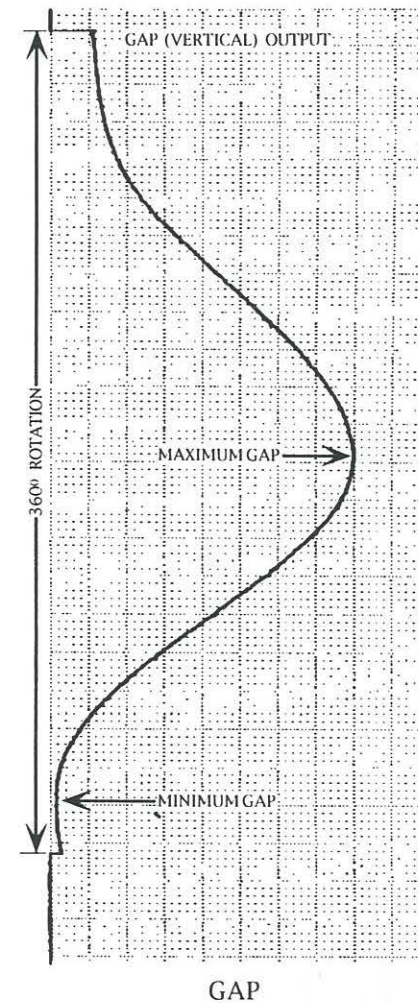
FIGURE 3 : Ultrasonic, Eddy Current, and Gap Calibration Signals

Ultrasonic signal-to-noise was judged satisfactory. This can be seen in the signals from the calibration notches and was evident in the data during scanning (Fig. 3). A strip chart display of the digitized data was generated as scanning took place. After scanning of a channel was complete, an "off-line" C-scan of the data could be generated (Fig. 4). This tended to greatly aid the detection of low level signals that might be lost in the noise of the compacted strip-chart, and allowed inspectors to verify whether echoes detected on successive rotations represented a flaw of axial extent or were simply the result of random reflections. The presence of serious flaws is not therefore expected to have gone undetected.

The eddy current equipment was quite satisfactory, and the STEM units worked very well with the eddy current flaw detection system. Reference signals from 0.15 mm deep (typ.) EDM reference notches generally showed a signal-to-noise ratio of about 3 (Fig. 3). As with ultrasonics, data could be displayed in an off-line C-scan format, which aids detection and characterization. An X-Y (impedance plane) re-display capability also enhanced the ability to characterize indications from the eddy current data (Fig. 4).

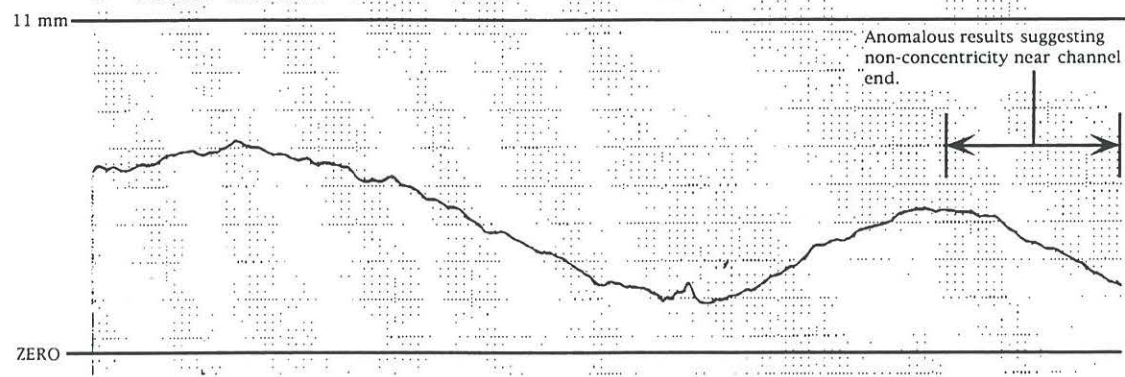
CHANNEL G12 BOTTOM-OF-CHANNEL AXIAL PROFILE

anomalies in the data. Examples are shown in Fig. 5. These were areas where the gap measurement data could not be reconciled with expected results based on other sources of information.

2. The gap measurement using eddy current gave anomalous results. For example, in J10 the measurement suggested the pressure tube might be near contact with the calandria tube, in the south channel end, which was not supported by ultrasonic inspection. Again, in the same channel the gap was measured to be highly nonuniform at a distance of 300 mm from the end fitting, which is difficult to accept since the tubes are expected to be concentric at this location.

1. The delivery system requires improvement to cope with abnormal channel sag, and an automated couplant collection system is necessary.
2. The accuracy of the gap measurement system may be increased by compensating the effects of wall thickness variation. This is based upon Ontario Hydro's SLAR and CIGAR experience, where a dramatic effect on eddy current signal is seen as a result of wall thickness variation, to the extent of 50% gap equivalent [2]. (Note however that the KANUPP 93 gap probe is different than those used on SLAR and CIGAR, and the effects of wall thickness are not expected to be as dramatic.)
