# Improved Operation In CANDU® Plants with CAN8 PHT Pump Seals

T. Graham<sup>1</sup>, D. McInnes<sup>2</sup>, and D. Rhodes<sup>1</sup>

## Abstract

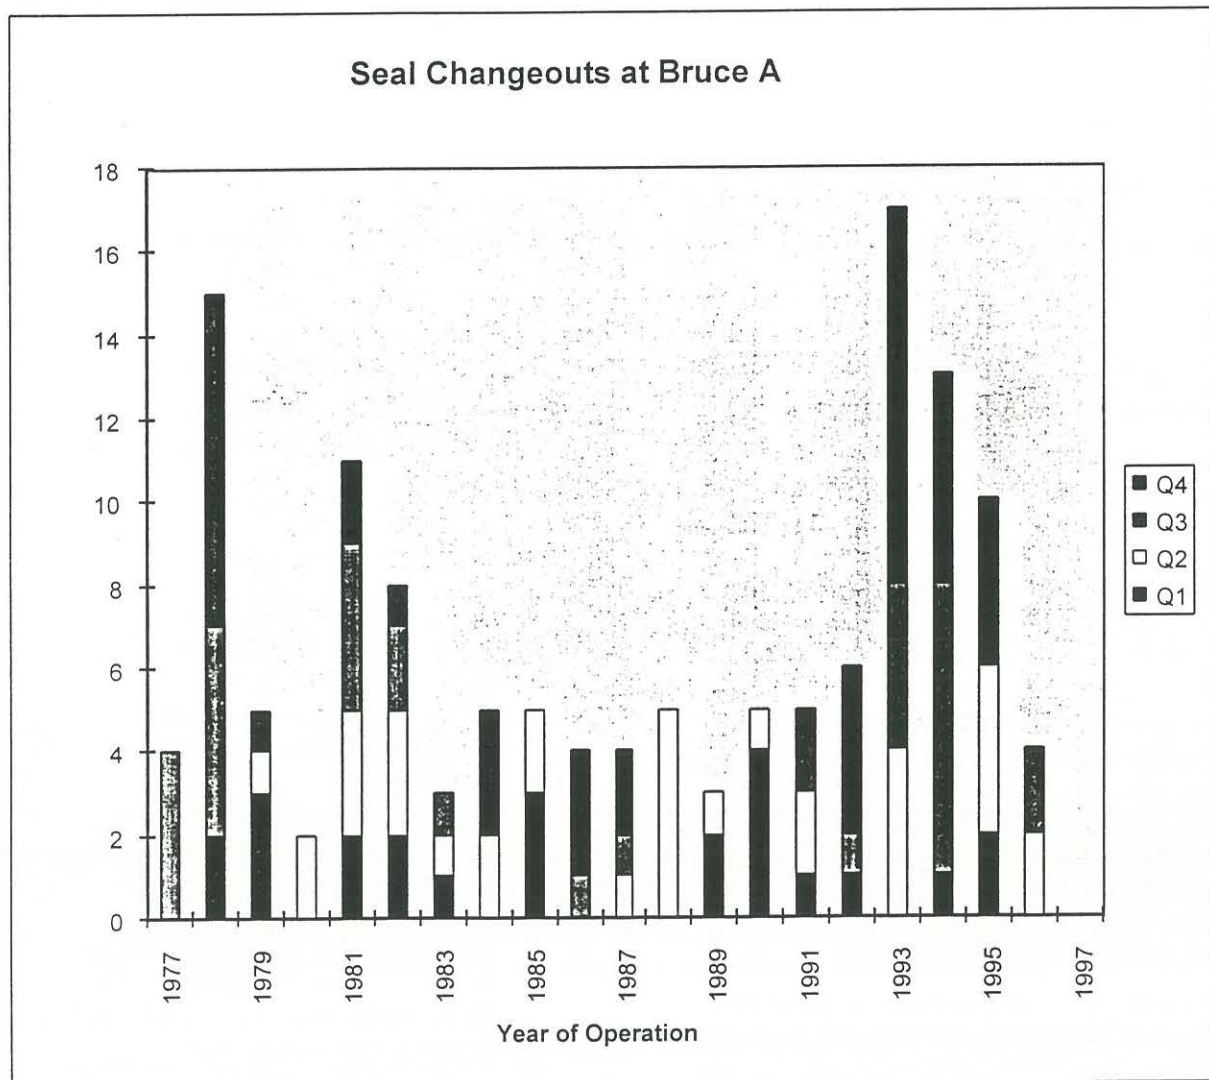
Fig. 1: Seal Changeout History at Bruce A.

The first CANDU installation of a CAN8 Primary Heat Transport Pump (PHTP) seal was in Unit 3 at Bruce A. An historical summary of PHT seal changeouts at Bruce A is shown in Fig. 1 —see Ref. 1 for details up to 1986. Fig. 1 shows a dramatic rise in the number of seal changeouts in 1993 following the 1990 introduction of low pressure running during the plant's start-up sequence. This accentuated the tendency of the stators in the CAN2 seal to rotate in their holders. As a result, symptoms such as rapid wear of the stator back face, overheating, and thermocracking began appearing. This weakness in the CAN2 design led to a decision to change seals. All operating units at Bruce A were converted to the CAN8 PHTP seal design between September 1994 and November 1995.

Bruce A. As shown in Fig. 1, Bruce A has now operated for more than one year without a PHTP seal change and if the current CAN8 seal performance continues, 1997 will be Bruce A's first full calendar year without a seal change. This good performance, coupled with a modification that ensures the seal is resistant to reverse pressure, led to the installation at Bruce B in December 1996. At the time of writing, seven PHTP's at Bruce B have had seal upgrades from the CAN2 to the CAN8.

1977 to 1981 — mixture of SU and CAN1 seals changeouts

1982 to 1993— changeover from CAN1 to CAN2 and CAN2 to CAN2 changeouts

1994 — 5 CAN2 to CAN8 and 8 CAN2 to CAN2 changeouts

1995 — 7 CAN2 to CAN8 and 3 CAN8 to CAN8 (2 with rough sleeve and 1 trial seal for inspection)

1996 — 4 CAN8 to CAN8 changeouts (1 rough sleeve, 2 reverse pressure induced and 1 sleeve friction related)

1997 — No changes to date

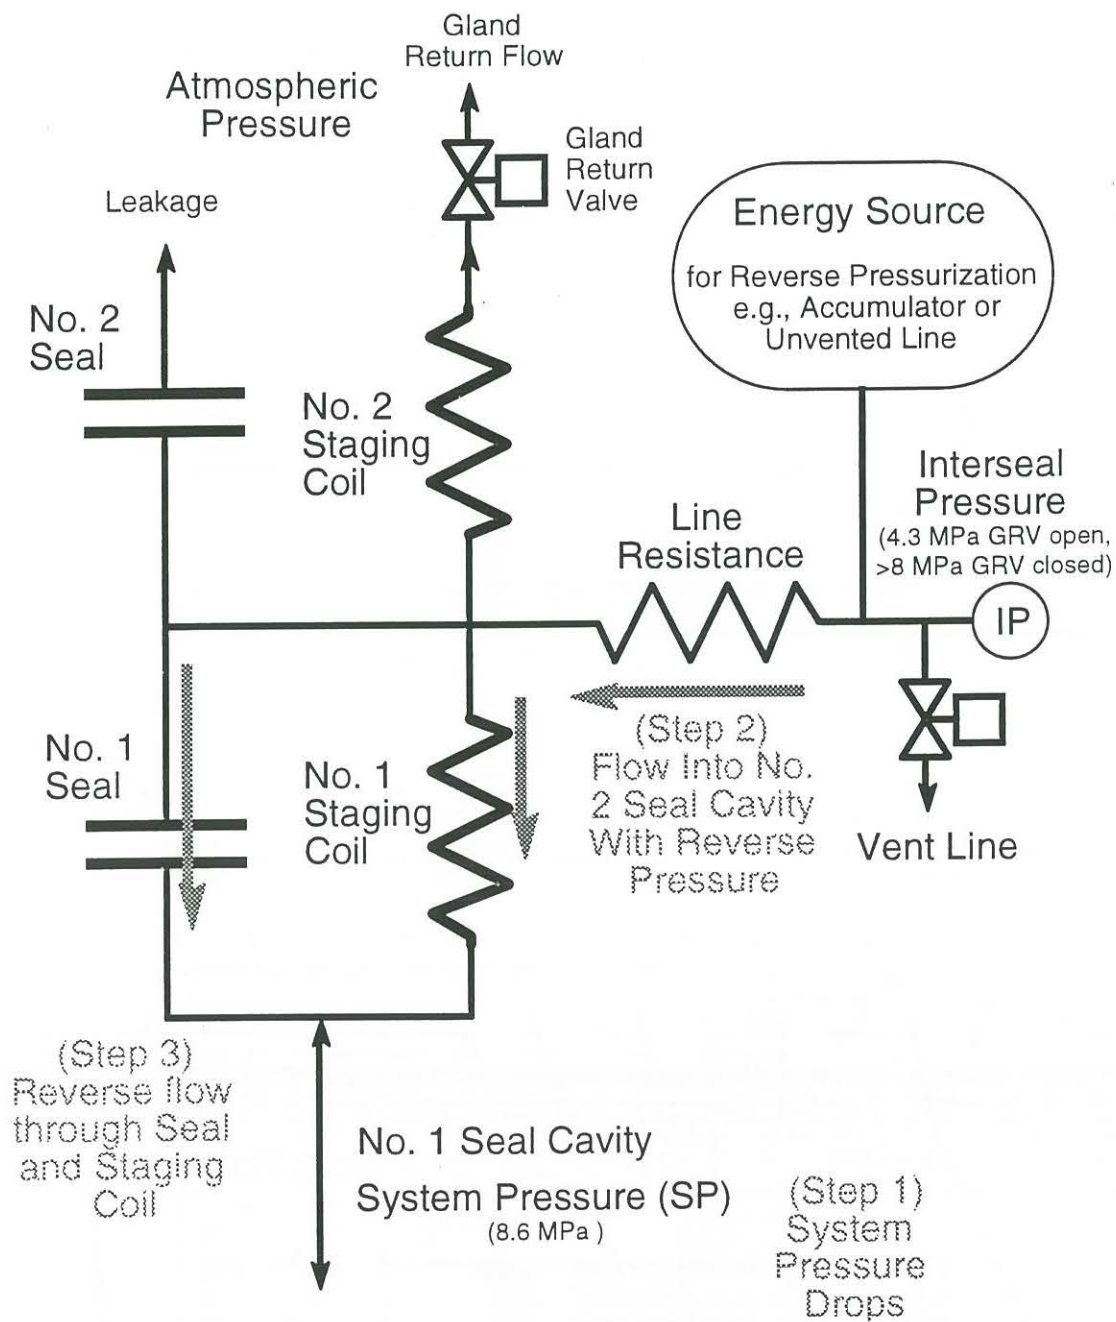
Fig. 3: Seal System for Reverse Pressure of the Primary Stage

Consider the system shown in Fig. 3. This flow schematic is for the two-stage seal system used at Bruce A and B. Normally the gland return valve is open and system pressure is divided about equally across the two seal stages. If system pressure suddenly drops below the interseal pressure, the direction of pressure drop across the primary stage will be reversed. When sufficient energy is stored in the system, e.g. air compressed in unvented instrument lines, gland return lines or the secondary seal cavity, the reverse pressure can be maintained and a reverse

Accordingly, the PHT and seal venting procedure was revised to include the following in the order given (after checking that the changes would not affect any other systems):

- opening the gland return line valve after seal injection is started and the seal cavity is filled,
- after the system pressure reaches 2 MPa, venting the seals for 30 seconds via the quick vent lines,
- opening the system valves as usual to vent the PHT piping.

This ensures that most of the air is out of the instrument lines and that the gland return line is free of air, and minimizes the size of any reverse pressure energy source. With the system venting done and when the gland return valve is open, the amount the system pressure can be reduced before getting below the interseal pressure is maximized.

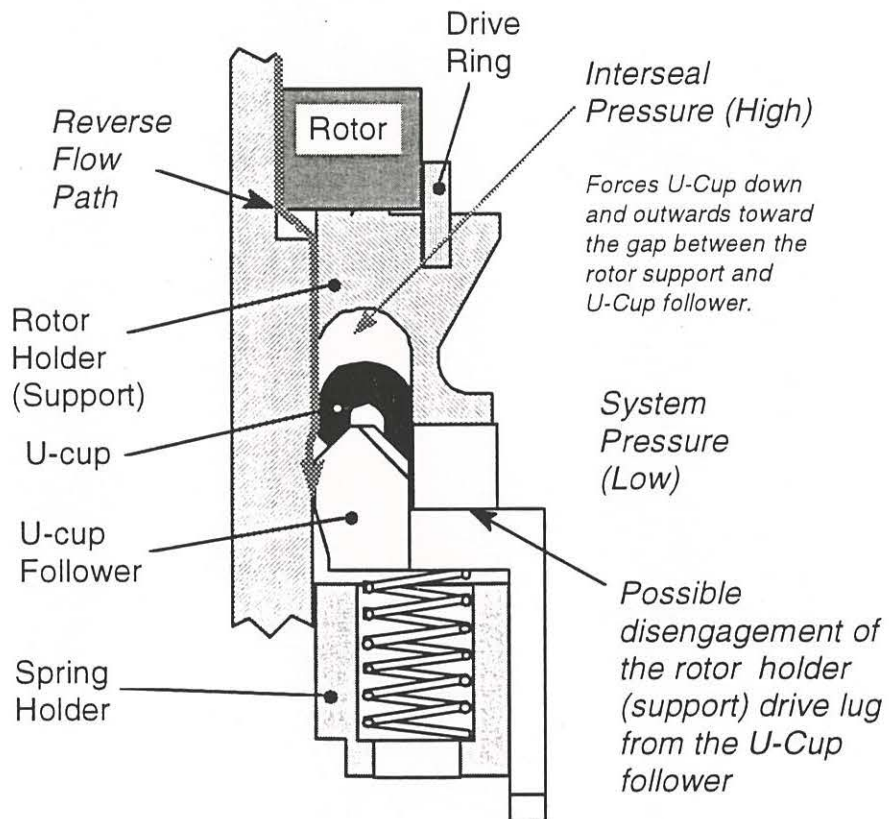
Fig. 4: Effect of Reverse Pressure on Primary Stage with CAN2 Design U-cup Seal.

flow generated through the primary stage. The reverse flow and pressure act against the back of the U-cup and, in the SU, CAN2 and Bruce A-CAN8 designs, if the force generated is greater than the spring force and flow is large enough, the U-cup can be pushed out of position as shown in Fig. 4. When the reverse pressure is relieved, the springs will act on the U-cup follower to close the gap. The normal result is that the U-cup is caught between the rotor support and the U-cup follower and it fails to reseal. This causes the seal to destage. The rotor support supplied to Bruce B is modified to prevent this from occurring.
