## **IN-TANK INSPECTIONS OF BURIED AND SUB-SURFACE HLW TANKS**

Waste Remediation & Enhancement Projects Division

Atomic Energy of Canada Limited

Chalk River Laboratories

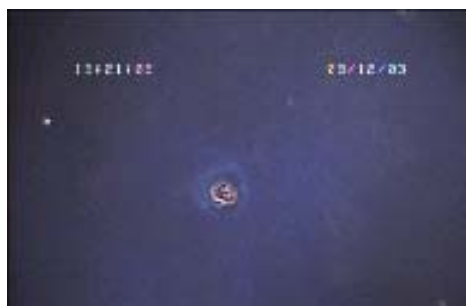
**Figure 4: Inspection of Inside Walls of Tank**

The camera was used to inspect the inside walls of the tank above the level of the waste. Inspections did not reveal any visible corrosion or cracking. One of the tanks appeared to be pitted (see Figure 4) but an expert determined that this was weld splatter formed on the inside of the tank during manufacturing and not pitting.

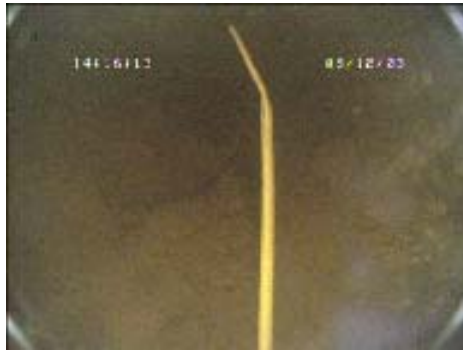
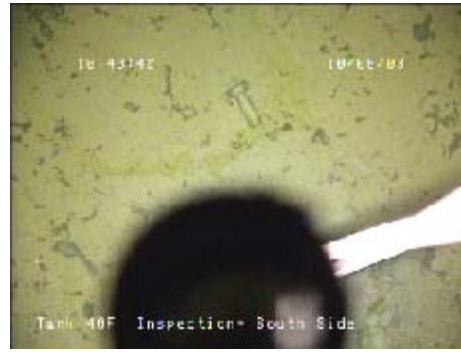
**Figure 5: Debris Discovered in the Tanks**

The camera was used to detect debris floating on the surface of the waste and also debris below the supernate. This is helpful in designing retrieval equipment appropriate for the wastes. Four of the tanks were found to contain debris. Figure 5 shows a tape measure and a bolt that were found in two of the tanks. Debris that had settled below the surface of the sludge could not be detected.

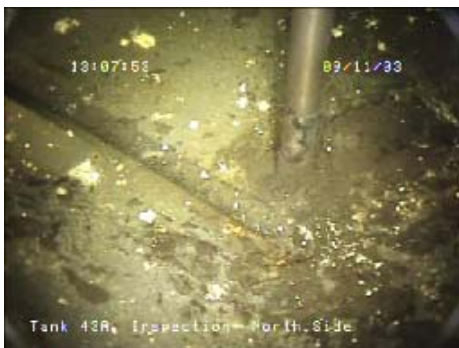
**Figure 6: Piping Modifications**

Camera inspection above and below the waste level was used to detect piping modifications or new penetrations in the tank. Only one of the tanks inspected revealed a discrepancy in the piping compared to the drawings. Figure 6 shows this discrepancy, a pipe situation along the centre line of the tank that was not shown on the drawing. The presence of this pipe will complicate installation and design of the retrieval nozzle. A similar pipe in another tank, based on the same drawing, could not be found. It may be present but hidden by the deep sludge in that tank.

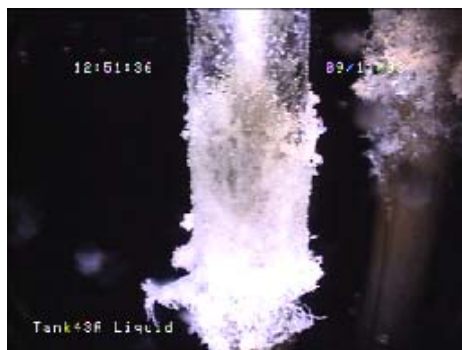
**Figure 7: Precipitate on Existing Lines**

The condition of existing lines was assessed visually using cameras. The inspections revealed that existing lines in the tanks are in reasonable condition considering the age of the tanks. Some of the lines were coated with precipitate that may impede use of existing lines for retrieval operations (see Figure 7).

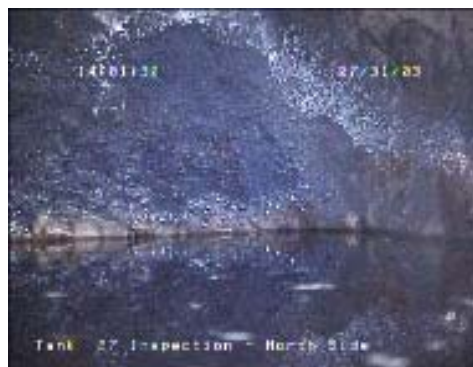
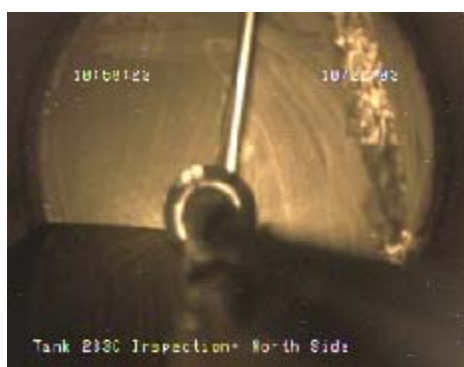
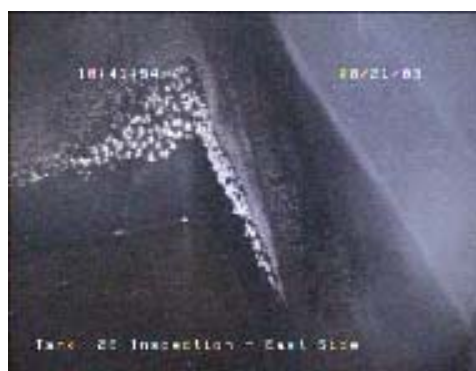
**Figure 8: Sludge and Salt Build-up on Internal Tank Walls**

The in-tank inspections revealed that sludge and crystals have built-up on the inside walls of 13 of the 16 tanks inspected. The other three of the tanks inspected contained highly acidic wastes (pH <0) and were relatively clean (see the second photo in Figure 8). The first photo shows sludge build-up while the last photo shows crystals that have formed on the tank wall. Wall washing equipment is required to properly clean these tanks.

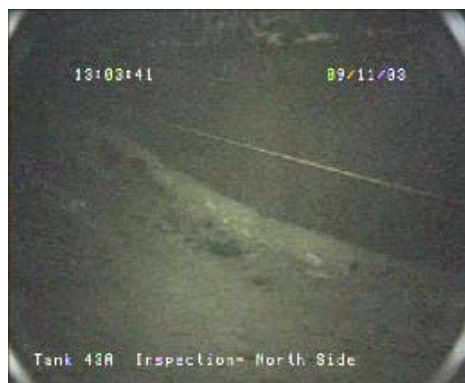
**Figure 9: Variation in Depth of Sludge**

Sludge volumes previously estimated using freezing methods were modified as a result of the camera campaign. Figure 9 indicates that measuring sludge depth at one location in the tank may not always be accurate as

sludge depth can vary throughout the tank. This “hilling” of sludge was only noticed in one of the tank.

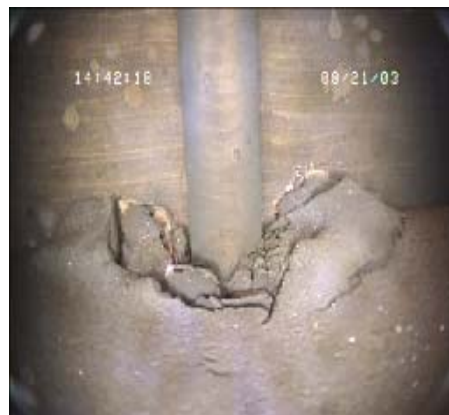
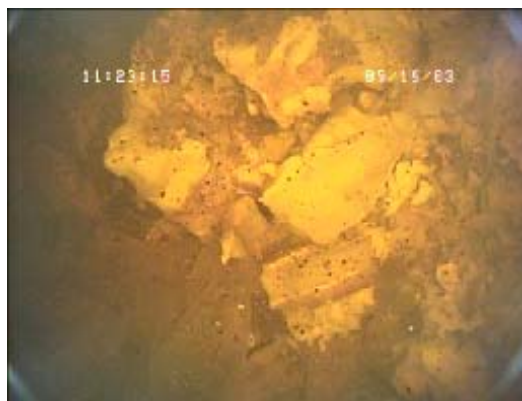
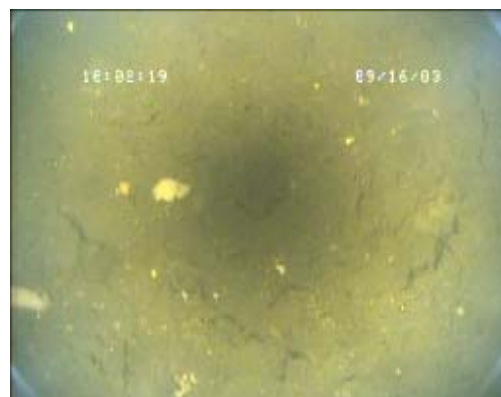
**Figure 10: Close-up Photos of Sludge**

By lowering the camera and rod through the supernate and into the sludge, the consistency of the sludge could be determined. (Is the sludge like baby powder or peanut butter?) This is important when designing retrieval equipment to avoid poor mixing, plugging of retrieval nozzles and settling in transfer lines. The first photo in Figure 10 reveals the surface of the sludge as seen through the supernate. Although the sludge looks hard and almost “asphalt-like” in nature, when prodded with a rod, it was discovered that the sludge was “ash-like” and could be easily mobilized. The second photo reveals the consistency of sludge, in a different tank. This zoomed-in magnification reveals the granular structure of the sludge. The third photo, taken in a different tank, reveals what might be metallic particles within the sludge.

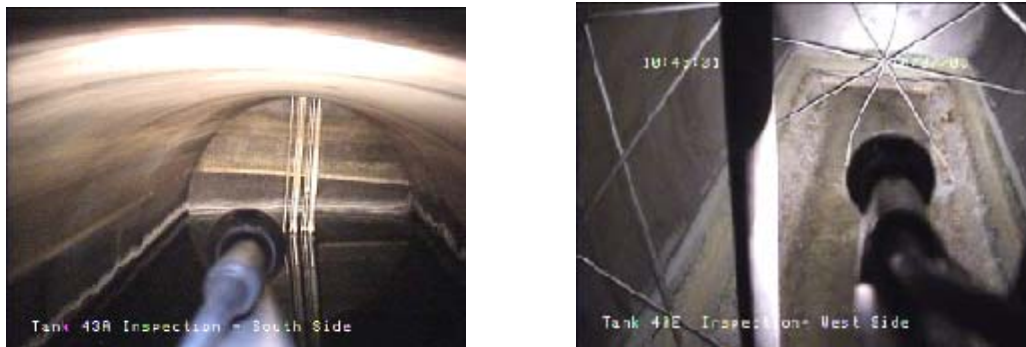
**Figure 11: Tank Abnormalities**

The in-tank inspections were also useful in identifying abnormalities in the current tank configurations. Figure 11 shows a tank with waste residue rings, from waste previously stored in the tank. These rings are not parallel to each other. This may indicate a shift or rotation in the tank. A thorough search of records revealed that this tank had not rotated or sunk but, rather, had been removed from service for several years and re-installed later at a slight angle. These residue rings may require aggressive cleaning methods to be completely removed.

The second photo in Figure 11 shows a cross-member support structure inside one tank. This structure was not on any of the tank drawings. Retrieval equipment design will have to avoid damaging this structure and also clean around it.

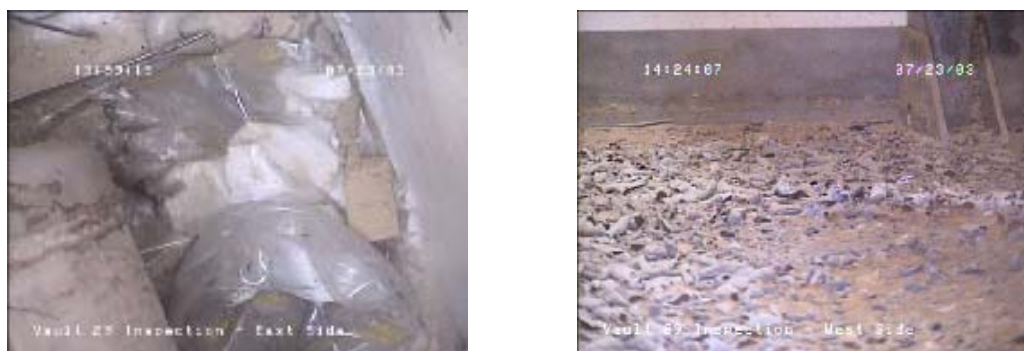
**Figure 12: Debris in Vaults**

The in-vault inspections revealed some debris in the tank vaults, as can be seen in Figure 12.

The photo on the left shows some plastic debris in one vault, while the photo on the right shows some mud inside the drip-tray underneath the tank. An investigation revealed that several years ago some of the vaults had been flooded for several days resulting in the muddy residue seen in this photo. No damage was caused to the tank or vault during the flood. No liquid was found in any of the vaults.

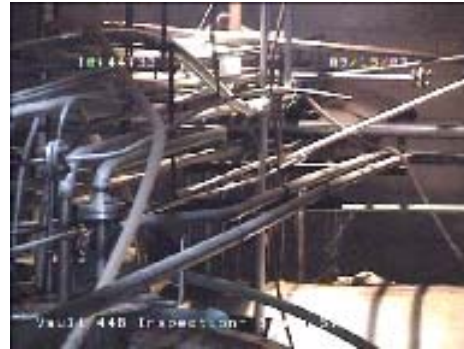
**Figure 13: Piping Above Tanks**

An important aspect of the in-vault inspections was determination of a suitable location to install new penetrations. Figure 13 reveals a maze of piping above the tanks that may impede the installation of retrieval equipment in the future.

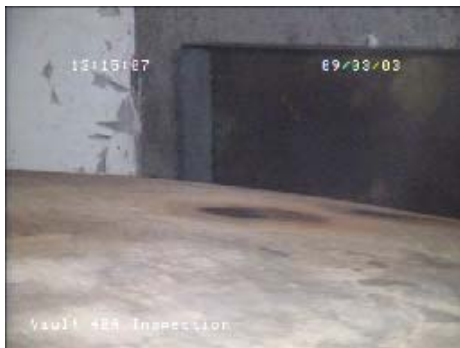
**Figure 14: Rust Spots on the Outside of a Tank**

Camera inspection of the vaults allowed visual inspection of the condition of the exterior of the tanks. Figure 14 shows some rust spots on the bell end of one of the tanks. Closer inspection of the video revealed that the rust was not a result of liquid rusting through from the inside of the tank but, rather, from a corroded pipe above the tank dripping on and staining the outside of the tank.

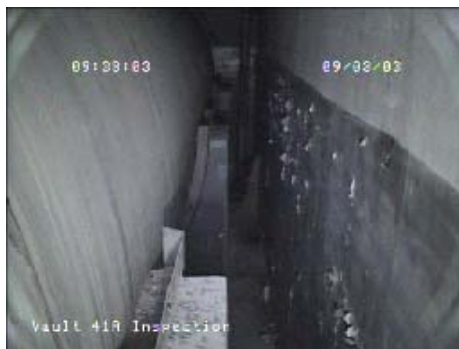
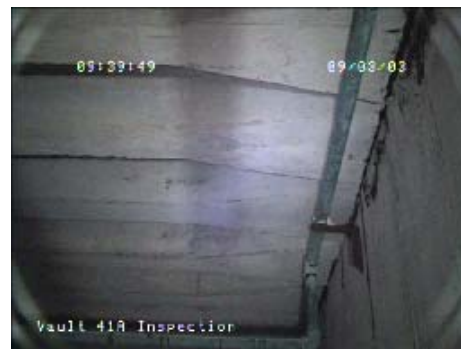
**Figure 15: Condition of the Vault**

The in-vault inspections allowed the inside of the vaults to be visually inspected for cracks and abnormalities. The photo on the left of Figure 15 reveals that the vault is in good condition with only some paint peeling. The photo on the right confirms the T-beam roof structure, shown on the drawings, of four of the vaults. This roof structure makes access into the vaults, through the roof, extremely difficult. These inspections also allowed for drip trays to be examined to ensure their drains were visibly clear.
