UPGRADING RADIOACTIVE WASTE MANAGEMENT FACILITY IN ARMENIA

Mark Gerchikov

Nuclear Safety Solutions Ltd.

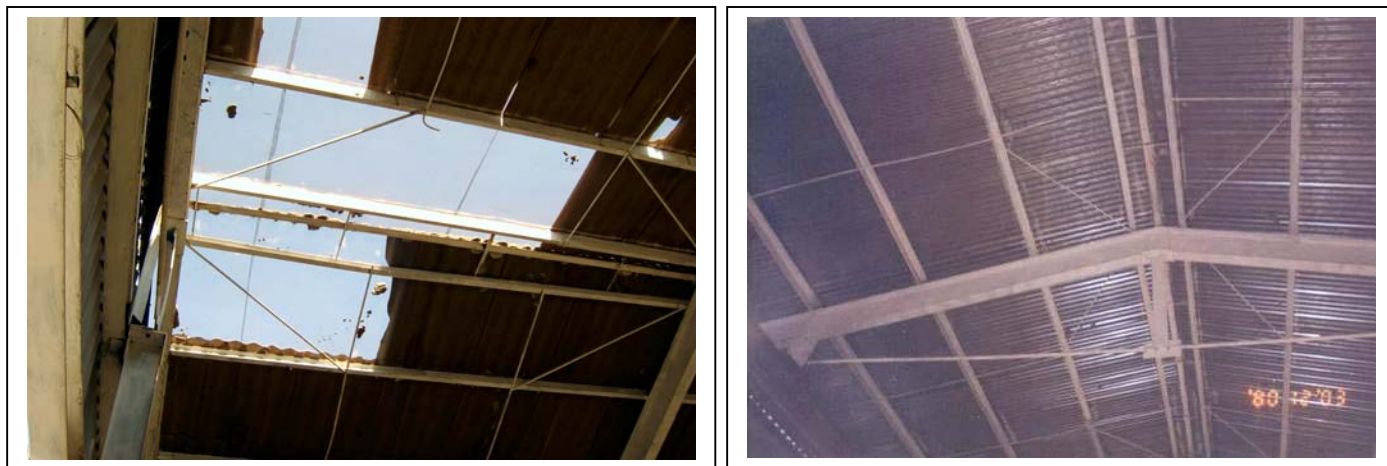
At the south end of the site, there are three waste storage/disposal buildings of which only one is used for management and disposal of radioactive wastes. By June 2003, window frames on either side of this building rotted, one of the wall panels was missing and the asbestos sheets

covering the roof were broken and missing (Figure 4a). In places, the concrete paving around the facility crumbled as a result of frost.

Figure 4: Roof of the waste disposal facility. (a) – Before the project (b) After the project.

Provision of the roof and missing wall panel and repair of the windows to prevent leakage in the facility addressed the top priority requirement within this package (Figure 4b). In addition the crushed concrete slab in front of the entrance to the facility was replaced to prevent dust resuspension.

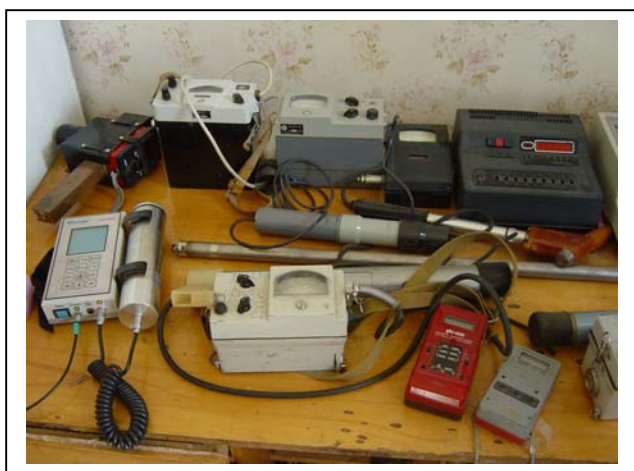
The facility had no Health Physics capability due to the lack of functioning Health Physics equipment apart from Soviet-made multi range gamma dose rate meter model number USSR CONTR SRP 68-03 that was made in the 1960s. Other old dosimeters were inoperable (Figure 5a).

Figure 5: (a) – Inoperable Soviet health physics equipment from 1970s.
(b) – Portable spectrometer supplied to the facility.
