## **AN OVERVIEW OF THE NASA PLUM BROOK REACTOR FACILITY DECOMMISSIONING - FACILITIES**

### **ABSTRACT**

The National Aeronautics and Space Administration (NASA) is nearing the successful completion of its \$230 Million (US), 12 year effort to decommission the Plum Brook Reactor Facility (PBRF). This paper will examine the challenges and solutions involved in the segmentation and removal of the reactor and its internals, and the decontamination of the hot cells.

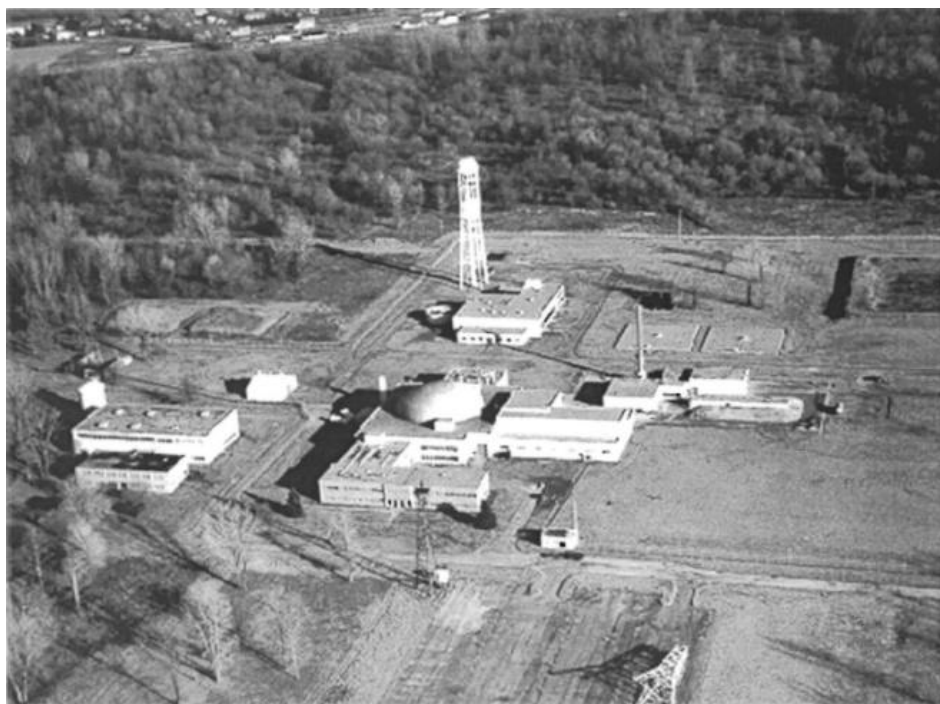
**Figure 1. The NASA Plum Brook Reactor Facility – circa 1987**

The NASA Glenn Research Center's PBRF is located near Sandusky, Ohio. It is halfway between Toledo and Cleveland, five kilometers south of Lake Erie. There are two US Nuclear Regulatory Commission (NRC) licensed reactors on site. The main reactor was a 60 MW pressurized water reactor and the Mock-Up Reactor (MUR) was a 100 kW swimming pool type. Both were used to perform neutron exposure testing on materials in support of the nuclear rocket program.

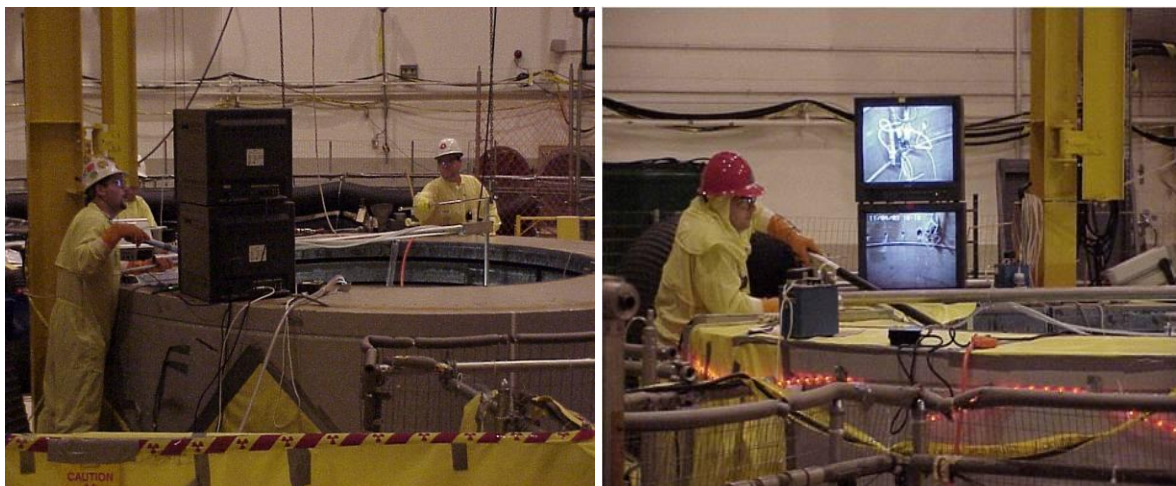
**Figures 3 and 4. Workers using remote viewing and long reach tools**

Workers from Wachs Technical Services (Wachs) then performed the disassembly of the reactor internals using standard tooling (wrenches, screwdrivers, etc) mounted on the end of 8 m poles. They manipulated these poles from behind the shields using 90 degree reach rods. The poles were suspended from jib cranes attached to the shrapnel shield outer wall. The workers were able to see what they were working on through the use of multiple in-tank cameras that they viewed on monitors, as shown in Figures 3 and 4.

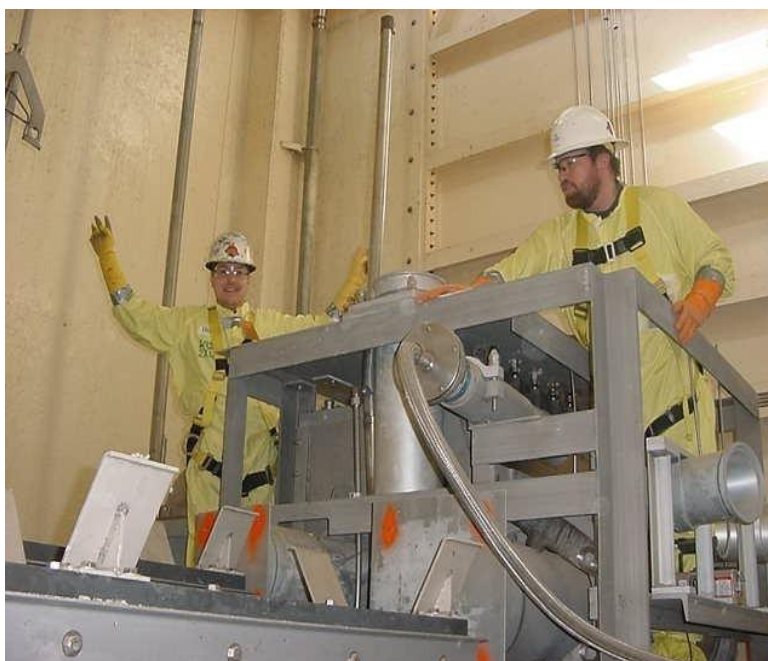
**Figure 5. Workers on the Mock Up Reactor**

The key to making this seemingly complex approach successful was that the workers were able to train and proof test all of the tooling and procedures in advance by disassembling the MUR. This swimming pool type reactor was physically identical to the main reactor, but the much lower power level it had operated at resulted in negligible dose rates. The highest on-contact dose for the MUR was 0.02 mSv/hr and the general area was background. A plywood silhouette was constructed to simulate the visual blockage created by the aforementioned shrapnel shields. Segmentation workers were able to 'test drive' tooling and handling techniques remotely while other workers were right on top of the action, as seen in Figure 5. They were able to see immediately why a particular tool or approach was not working, make the correction, and test it out. They also worked out optimum camera positioning. Once a step was mastered on the MUR it was executed on the main reactor.

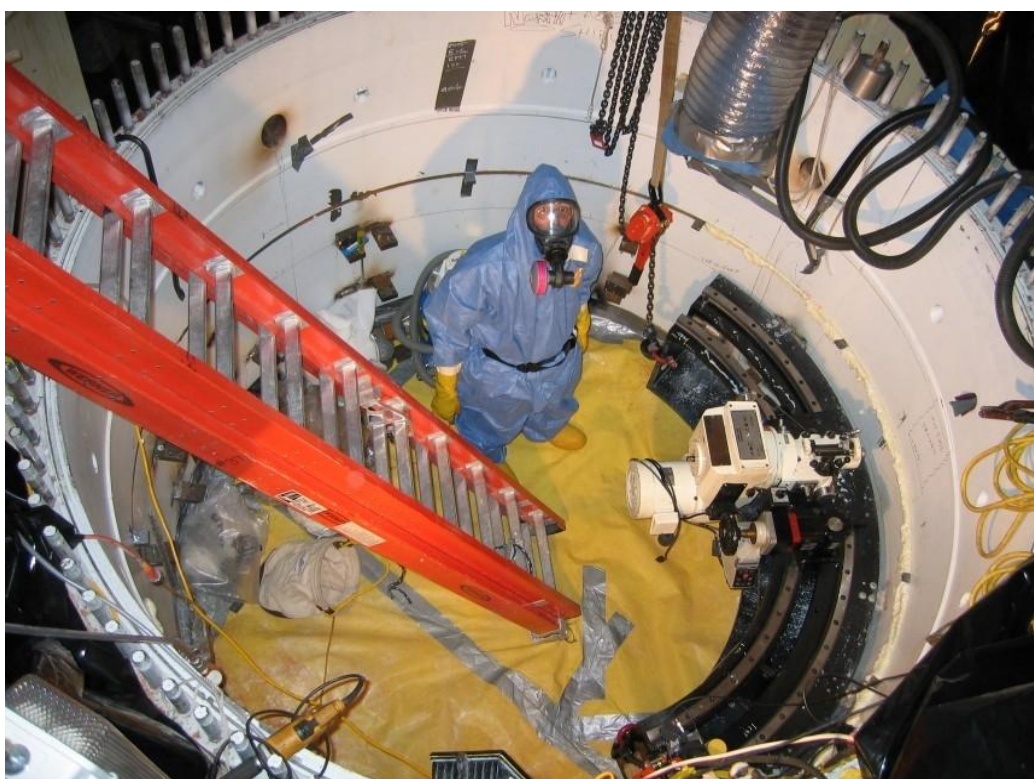
**Figure 6. Segmenting the vessel with a milling machine**

The first step was to spray the entire interior surface with “lock down” (essentially, white paint) to fix any loose contamination in place. Next, a scaffolding arrangement was installed that allowed access to one meter sections of the vessel at a time. A milling machine track was tack welded to the tank wall in a vertical orientation, and several passes of the mill were used to cut through the tank wall, as shown in Figure 6. A number of vertical cuts were made at each elevation – the exact location driven by the location of vessel penetrations and keeping the size of the resulting pieces manageable. This typically resulted in four to five cuts per level.

The track was then tack welded to the tank wall horizontally, and one by one the pieces for each layer were removed. Prior to cutting a piece, it was secured by overhead cables so that workers or tooling would not be put at risk when it came free. As each layer of tank wall was removed, the scaffolding floor was lowered, and the process was repeated.

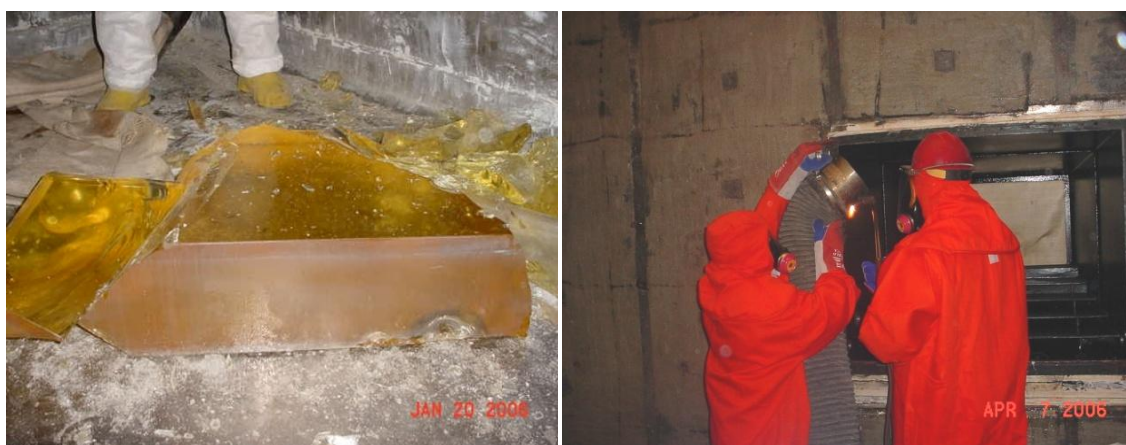
**Figures 9 and 10. Removal of hot cell window glass and frame**

The decision was made to dispose of the windows. Given the high lead content of the windows a Toxicity Characteristic Leaching Procedure (TCLP) was conducted; the window failed, meaning they had to go out as "mixed waste." Each 1.3 m thick window was actually made up of multiple layers of .25 m thick glass. Size reduction was simply a matter of attaching a rope to a glass slab and pulling the rope from outside the cell. The window would fall to the floor and shatter, resulting in chunks as seen in Figure 9. Where necessary, the chunks were further sized reduce with a sledge hammer, and the glass was then shoveled into 55-gallon drums which were sent off site for macro encapsulation. Once the glass was gone, workers removed the steel window frame using cutting torches, as shown in Figure 10. This work had to proceed with caution, as there were typically 7,000 kg of lead wool and lead shot packed in around each frame that had to be removed first.

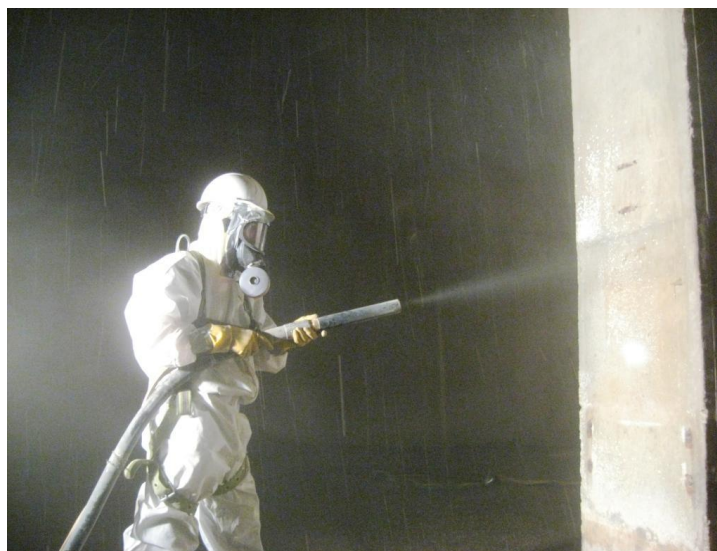
**Figure 11. Sponge Jet blasting**

The removal and decontamination of the 20-ton concrete roof slabs came next. These were able to be decontaminated and free released using sponge-jet blasting. This is similar to sand blasting using small sponges embedded with abrasive material in place of blast grit. Figure 11 shows a worker performing sponge-jet blasting. The chief advantage is that after use the

sponge media and debris are easily separated using a vacuum cleaner. The heavier debris drops out, but the light sponge is carried along to a different hopper. This way, the “sponge media” can be recycled up to a dozen times before it wears out. The result is a significant savings in waste volume. With the roof gone, the concrete intercell transfer doors were next. High levels of embedded contamination made it impractical to clean these “blocks,” and they were disposed of. All walls were cleaned via sponge jet blasting, leaving a surface to clear of paint and contamination to survey. Floors were cleaned using a Marcris Floor Shaver, seen in Figure 12. When used with an attached HEPA unit it was unnecessary for workers to use respirators, even in situations where there was asbestos. Figure 13 shows the cells ready for FSS.
