# Improved Operation In CANDU® Plants with CAN8 PHT Pump Seals

T. Graham<sup>1</sup>, D. McInnes<sup>2</sup>, and D. Rhodes<sup>1</sup>

## Abstract

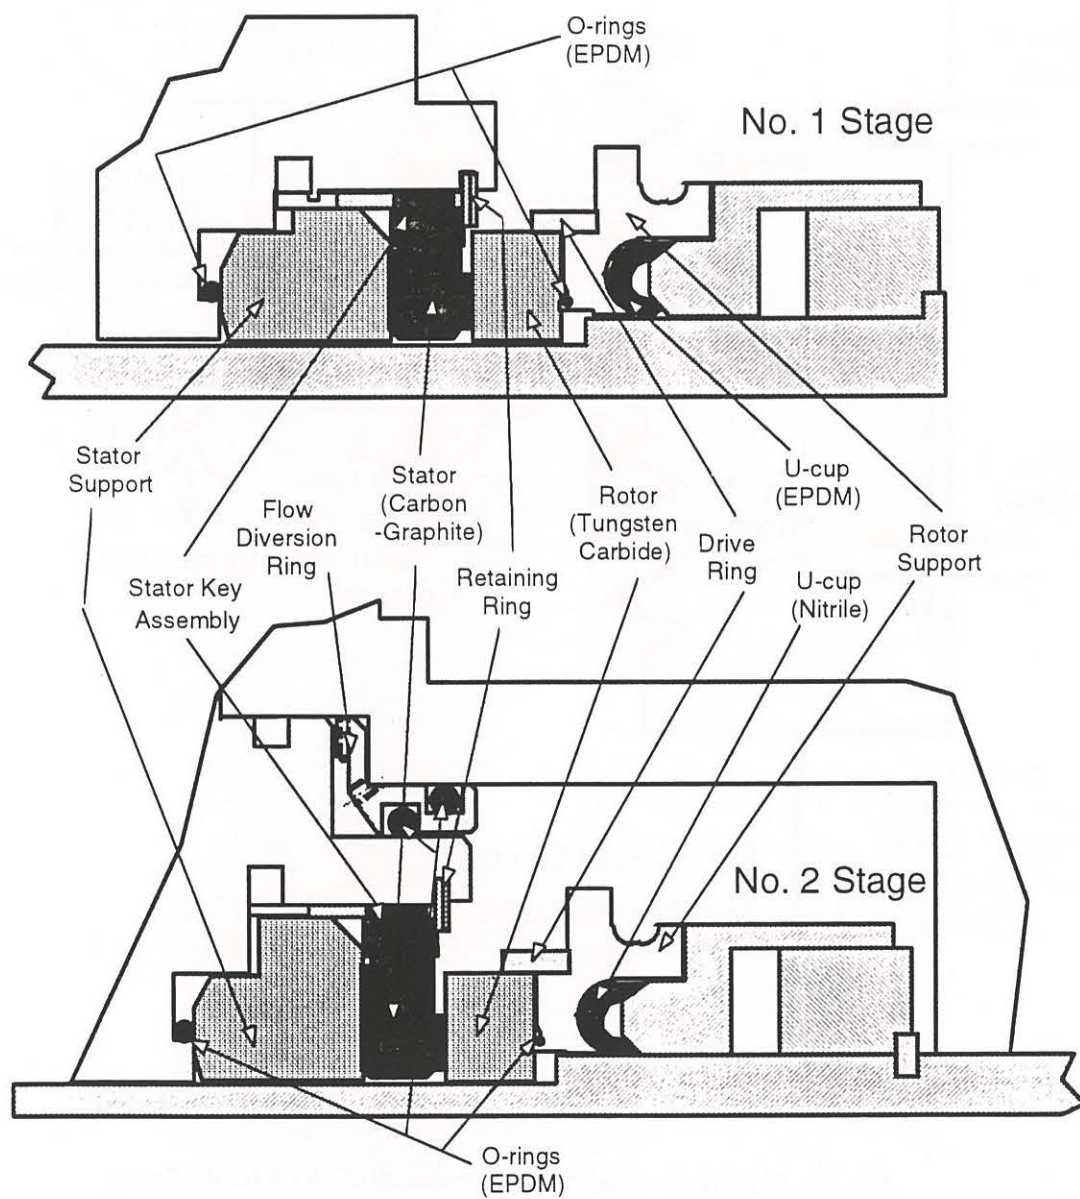
Fig. 2: Two-Stage CAN8 Seal for CAN2 Replacement.

The CAN8 design, shown in Fig. 2, replaces the AECL-designed, Byron Jackson-supplied, CAN2 PHTP seals in CANDU® plants and the earlier Byron Jackson SU design in Boiling Water Reactors (BWR's). Designed in 1991 for BWR and CANDU® service, the CAN8 seal is capable of operating at high or low pressure with no loss in performance. This capability is achieved through improved control over seal face deflections derived from low hysteresis between the seal rings and their supporting surfaces, Ref. 3.
