UPGRADING RADIOACTIVE WASTE MANAGEMENT FACILITY IN ARMENIA

Mark Gerchikov

Nuclear Safety Solutions Ltd.

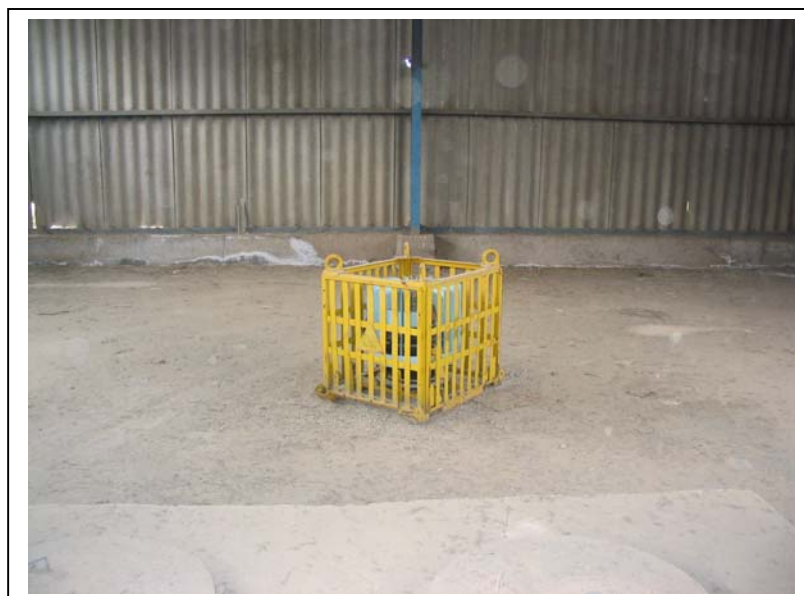
Figure 2: Radioisotope thermoelectric generator, originally containing 30 000 Ci of ^{90}Sr

In addition to relatively small sources, there is also a single 30 000 Ci (1 Million GBq) Sr-90 source, which is temporarily stored at the facility (Figure 2). In the past this radioisotope thermoelectric generator (RTG) was used to power a meteorological station by producing electric power from radioactive decay. By now Sr-90 activity will have decayed to below 15 000 Ci; however, the source still represents a significant security and radiological safety concern. This Sr-90 source is the only RTG in Armenia, and the country has no infrastructure for safe storage and long-term management of large sources.

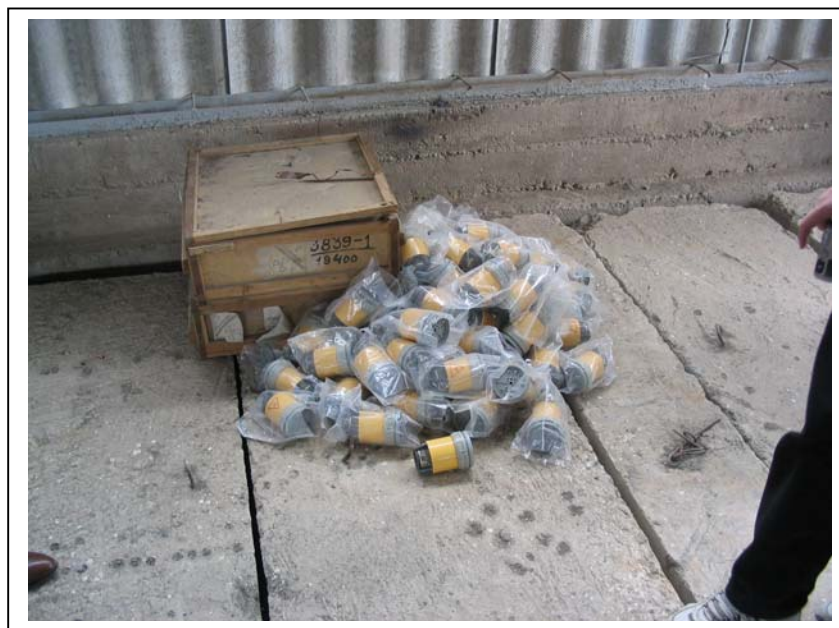
There are also several Pu-239 sources from smoke detectors of the old Soviet design (Figure 3). It was estimated that the current inventory of fissile material at the ‘Radon’ facility does not present criticality concerns. However the facility is not allowed to encapsulate or dispose long-lived wastes.

Figure 3: New batch of used smoke detectors, containing very small quantities of ^{239}Pu
